Manhole Inspection Summary

Manhole # S150__050MH

Insp Date: **2/24/09 3:35 PM**

Location Address: **2660 LEHMAN ST**

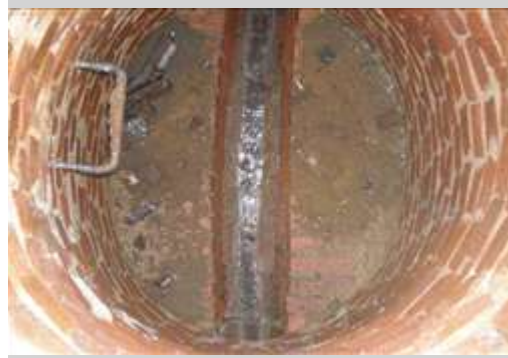
Top View

Comments **OBSERVED MH WITH WATERTIGHT COVER THAT IS SEALED IN FRAME - BROKE OPEN WITH 16LB MAUL AND REPLACED WITH NEW 24" SANITARY LID. INSPECTION COMPLETE.**
